**Passaic Valley Sewerage Commissioners  
Response to Request for Information  
USEPA, Region 2**

**Service Area Drainage and  
Land Use Report  
for the Towns of  
Harrison and Kearny,  
The Borough of East Newark, and the  
Cities of Newark and Paterson**

**Combined Sewer Overflow**

**The Towns of Harrison and Kearny and  
The Borough of East Newark**

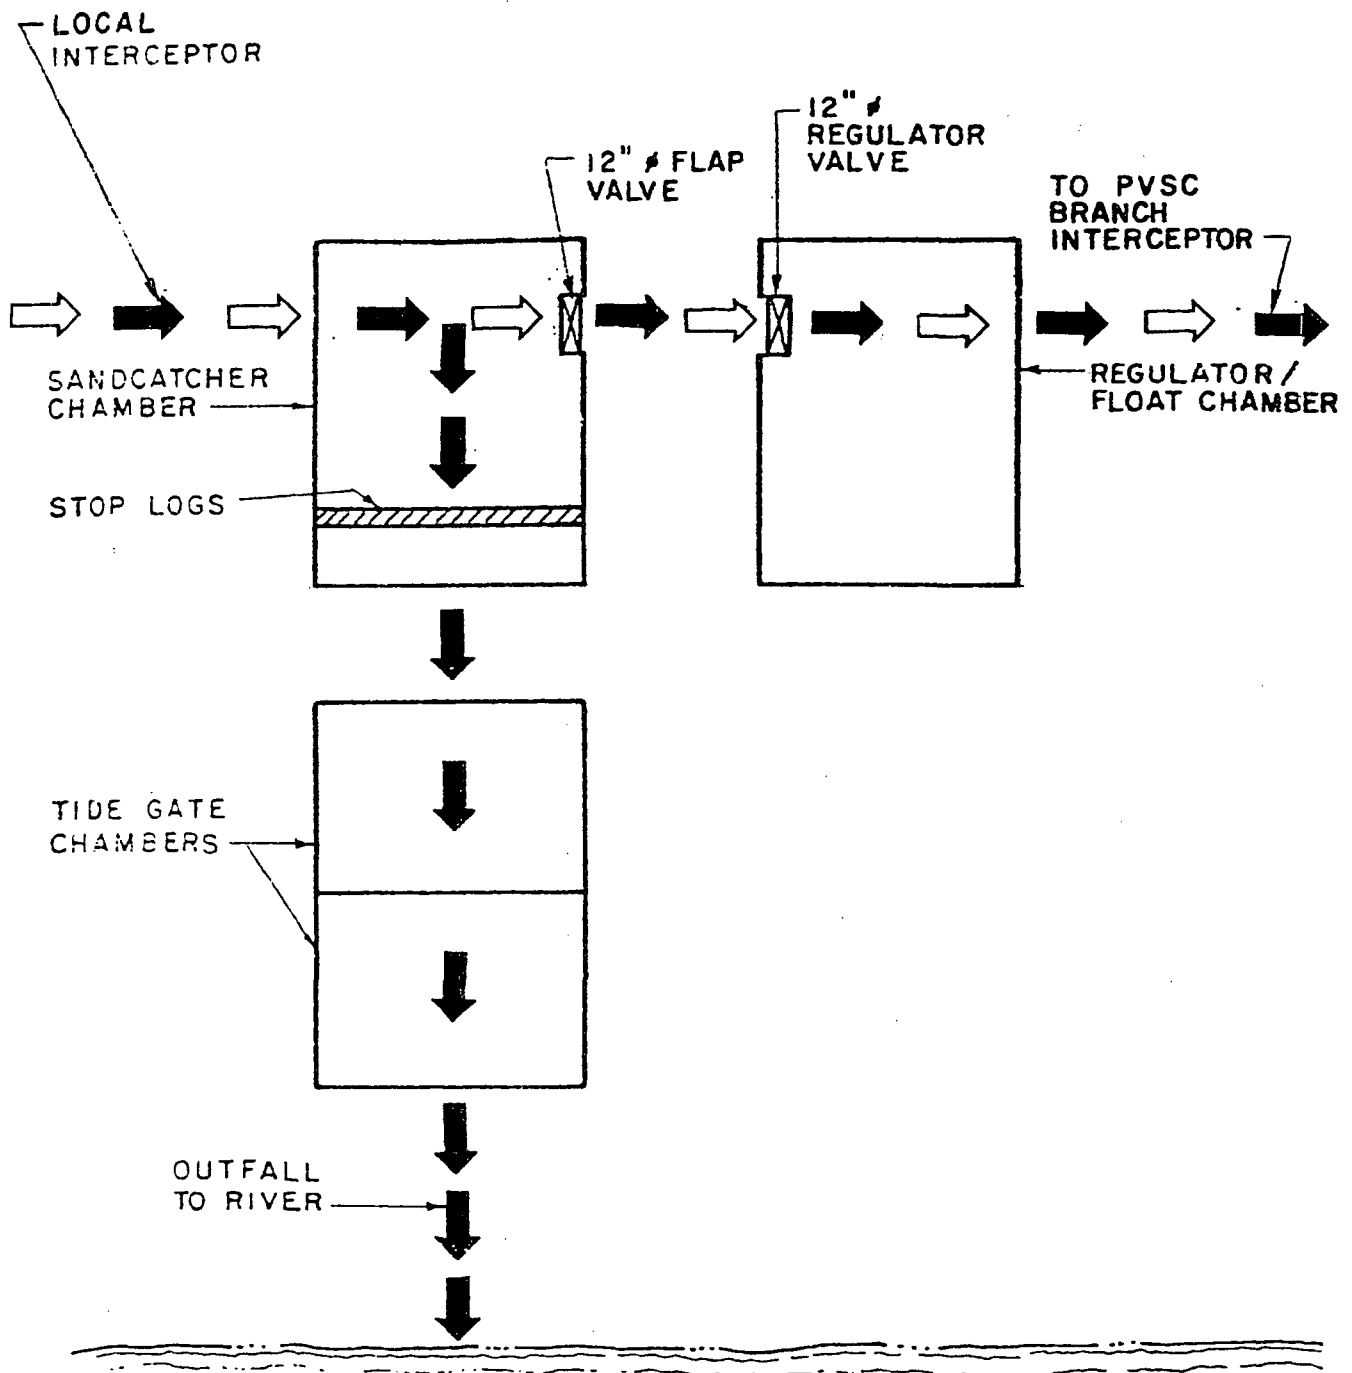
NEW (HAMILTON) STREET OVERFLOW CHAMBER  
Condition of Regulator:

Tide Gate Condition:

both tide gates noted as leaking

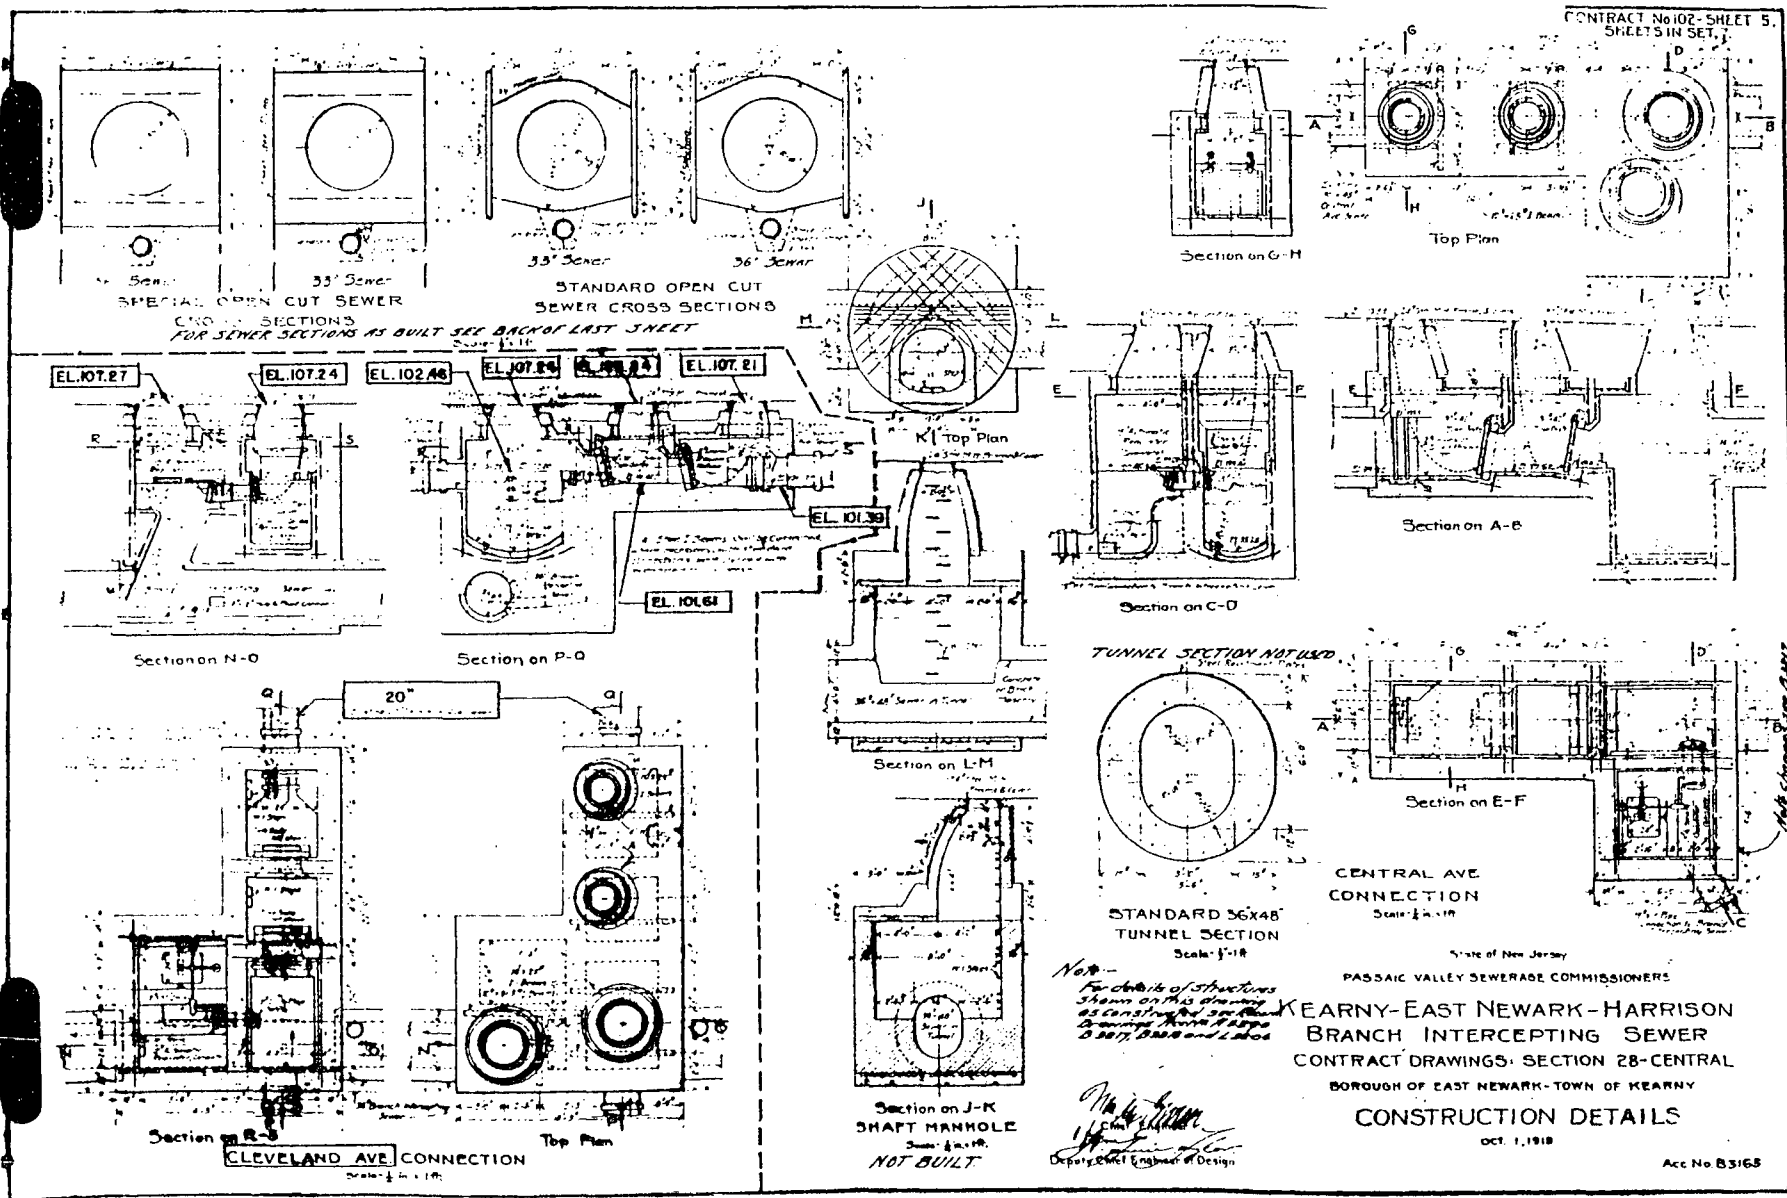
Tide Gate Condition:

both tide gates noted as leaking

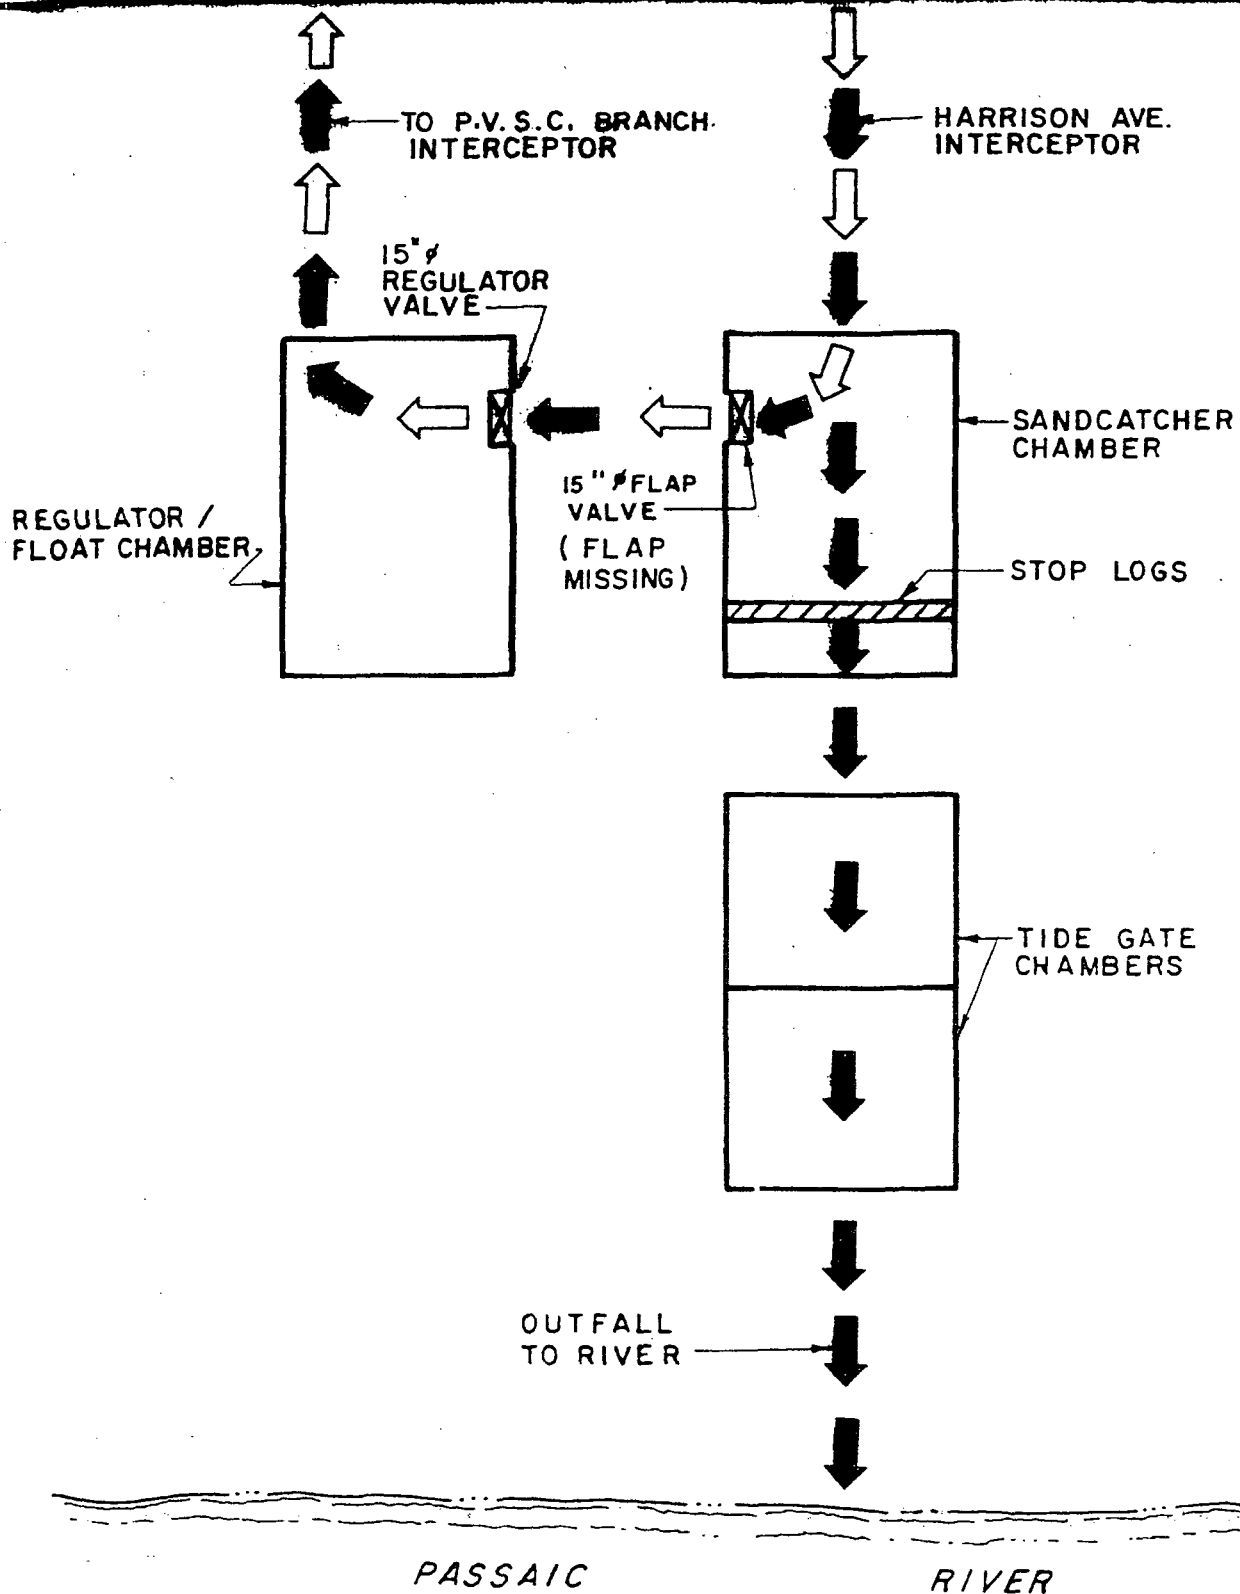
Condition of Regulator: appears inoperable

Tide Gate Condition:

both tide gates leaking

The area tributary to this overflow is small. A separate sanitary sewer is recommended for connection to the PVSC branch interceptor, with elimination of this combined overflow.

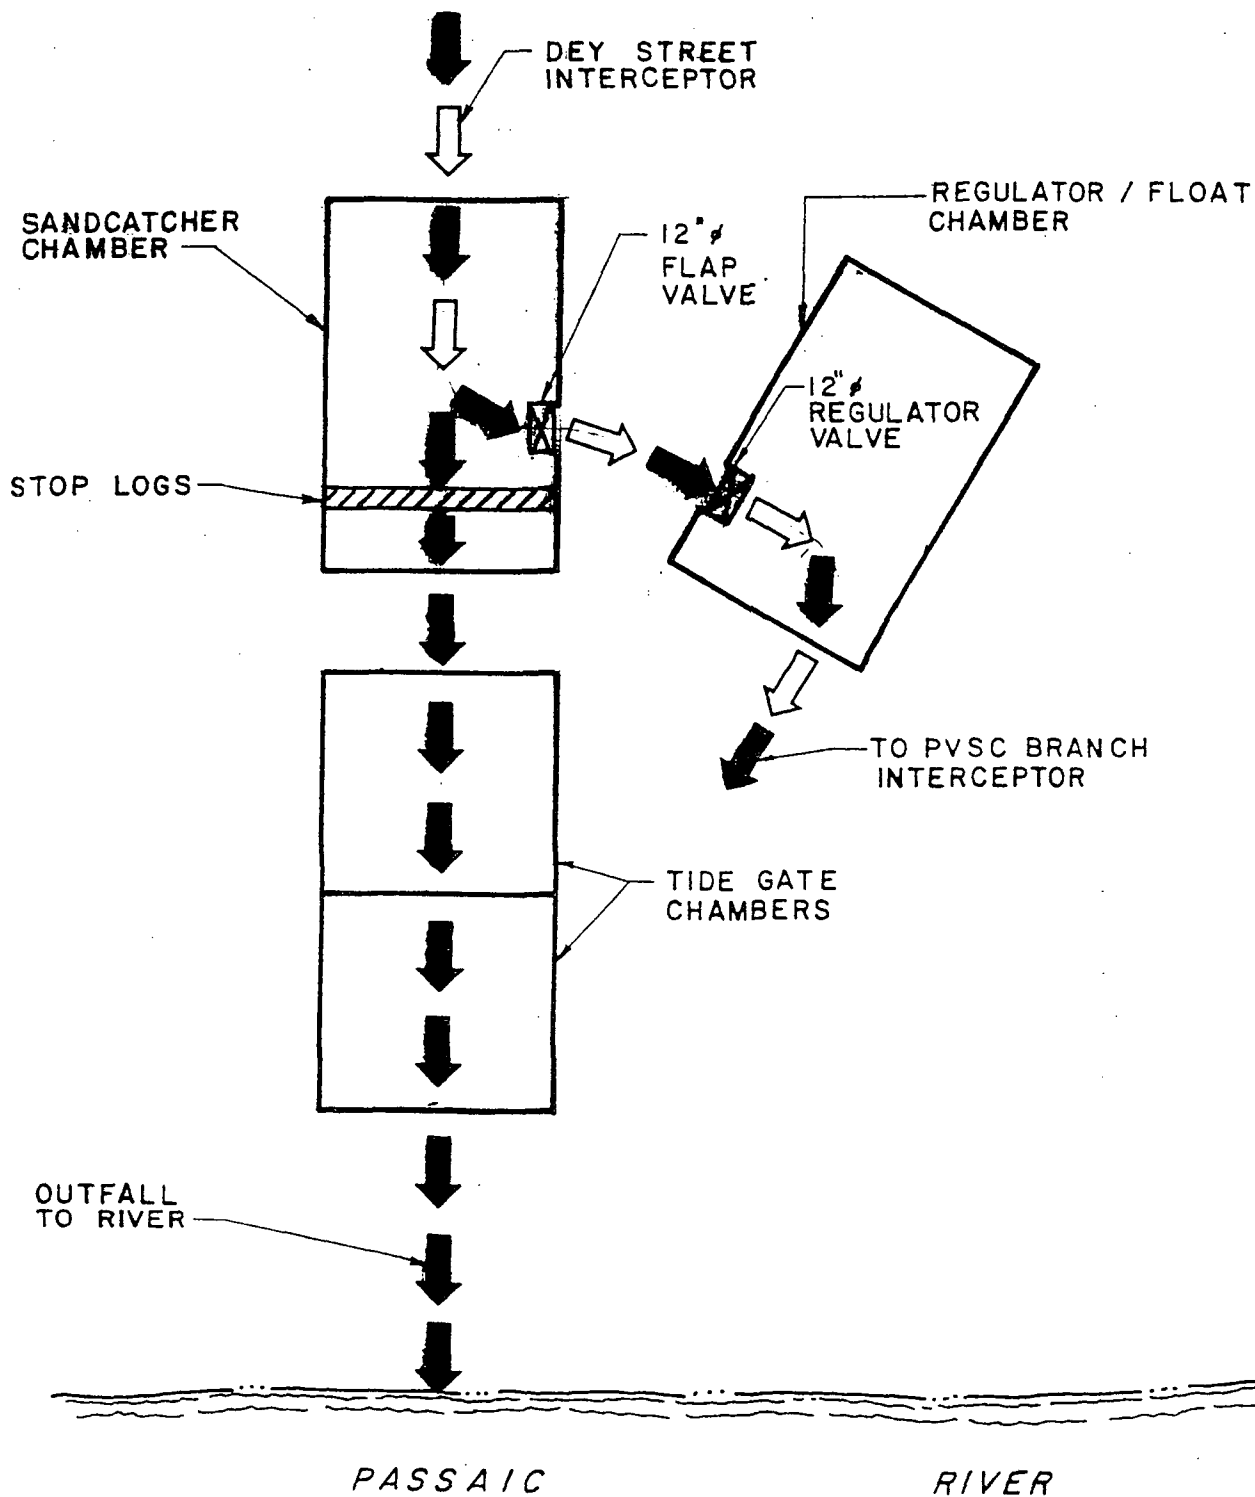
Condition of Regulator:	appears inoperable
Special Actions Required:	none
Overflow Stop Log/Dam Condition:	stop logs located in downstream end of sand catcher just before opening to first tide gate chamber
Tide Gate Condition:	first tide gate leaking; second tide gate not accessible due to buried manhole cover

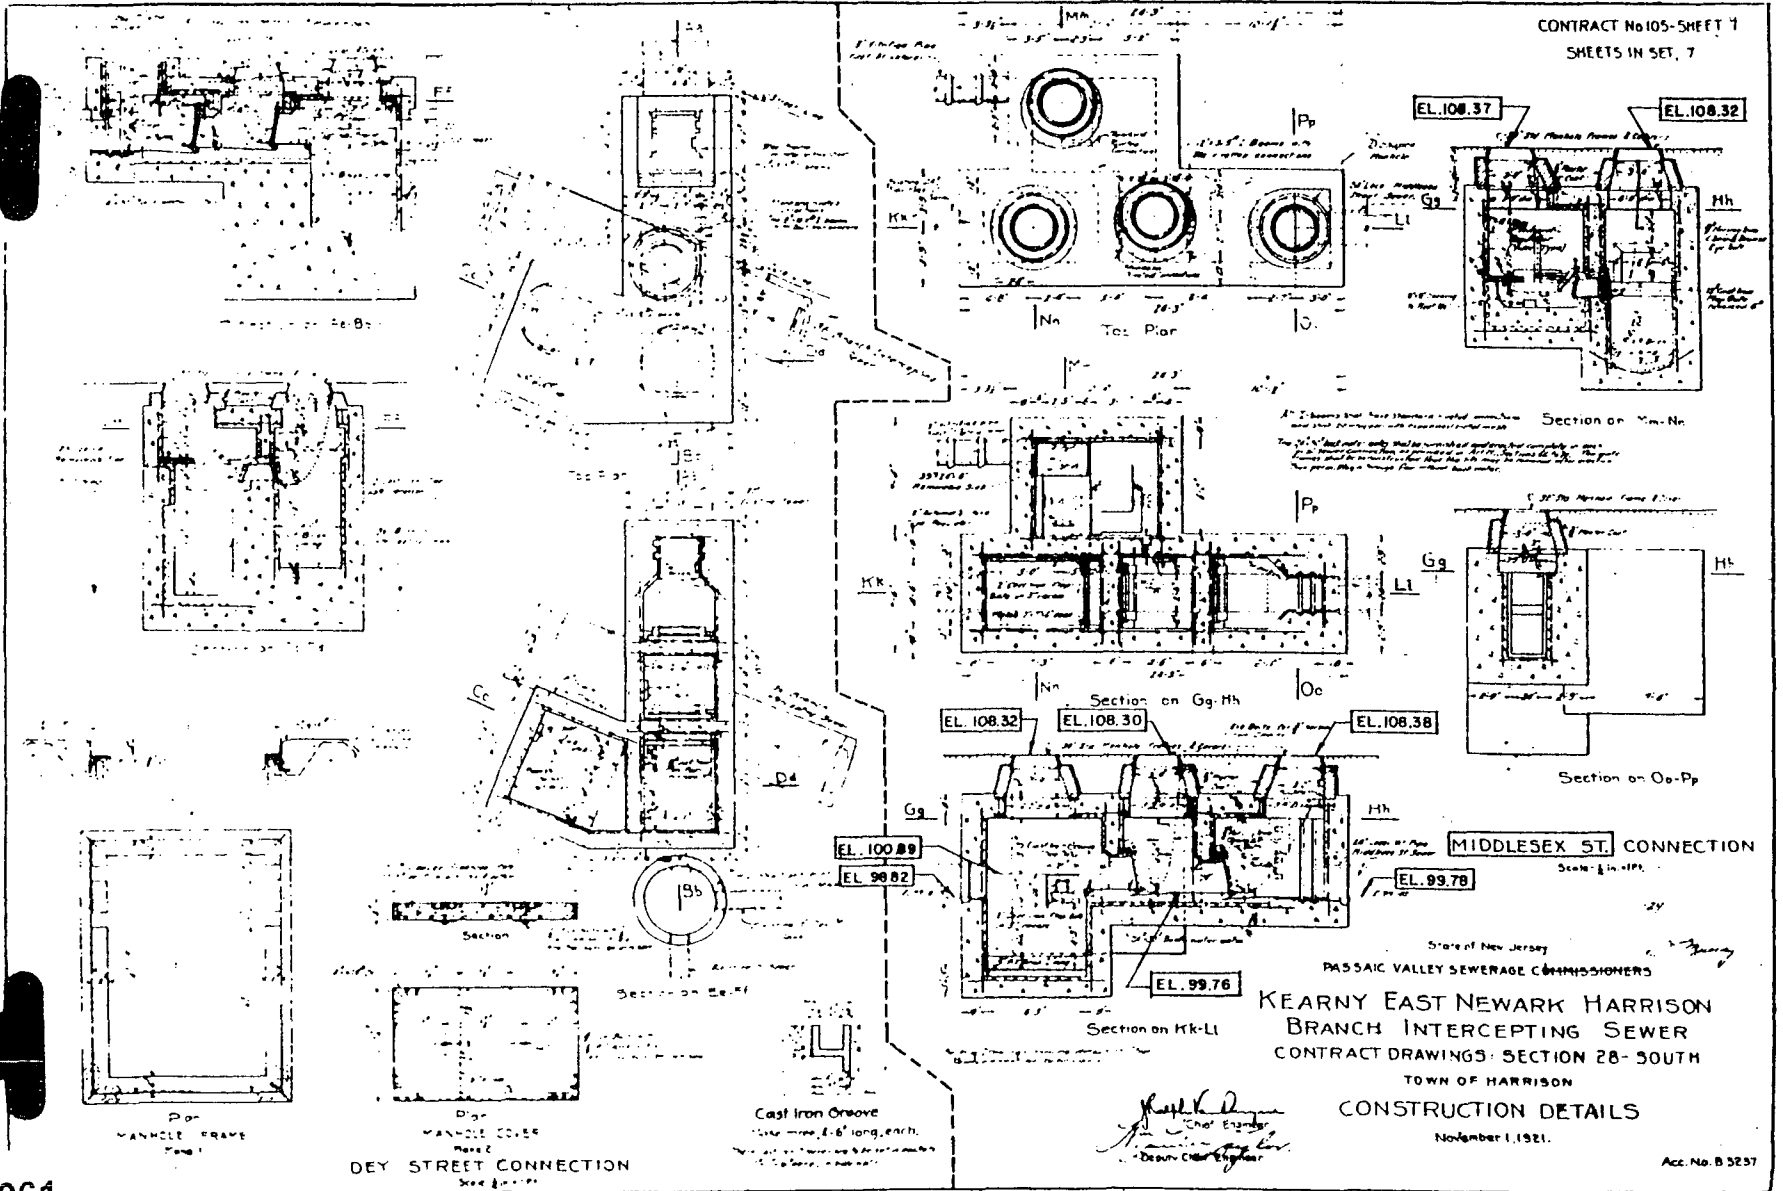
Condition of Regulator: appears inoperable

Overflow Stop Log/Dam  
Condition: stop logs located in downstream end of  
sand catcher just before opening  
to first tide gate chamber

Tide Gate Condition: both tide gates noted as leaking
